DJS ASSOCIATES

THIS ANALYSIS IS BASED ON PUBLICLY AVAILABLE DATA AS OF FEBRUARY 25, 2021

JUSTIN SCHORR, PH.D

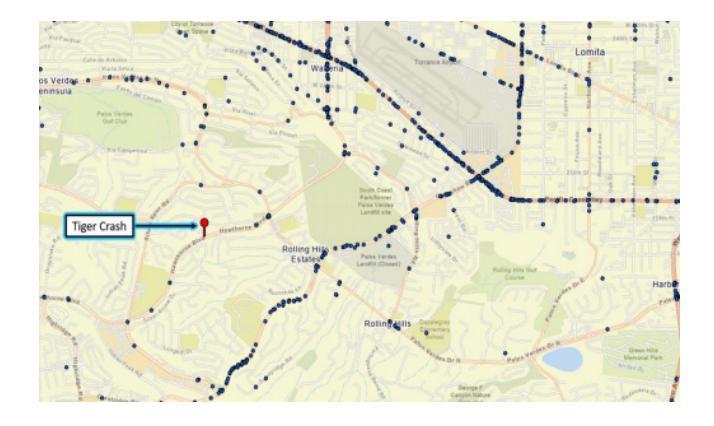
It should be mentioned that Hawthorne Boulevard northbound, in this immediate area, is on a downgrade which approaches 10%. This downgrade, while steep, can still be safely and easily navigated consistent with data from the California Statewide Integrated Traffic Records System (SWITRS) – a statewide database maintained by UC Berkeley – which shows that there were no other substantially similar collisions within an approximately ½ mile radius for the most recent 10-year period in which crash data is available (2010 – 2019).

[*This database includes, apparently, all California collisions where an injury, including minor ones, was reported (approximately 720,000 collisions between 2010 and 2019 in Los Angeles County). Within the noted radius (which does NOT include the intersection of Hawthorne Boulevard and Palos Verdes Drive), there were no reported collisions in the northbound travel direction (Tiger's direction of travel) and there was one reported collision in the southbound travel direction. The southbound collision occurred in 2010.]

Here is a map showing the location of Tiger's collision along with those in the Statewide Database between 2010 and 2019:

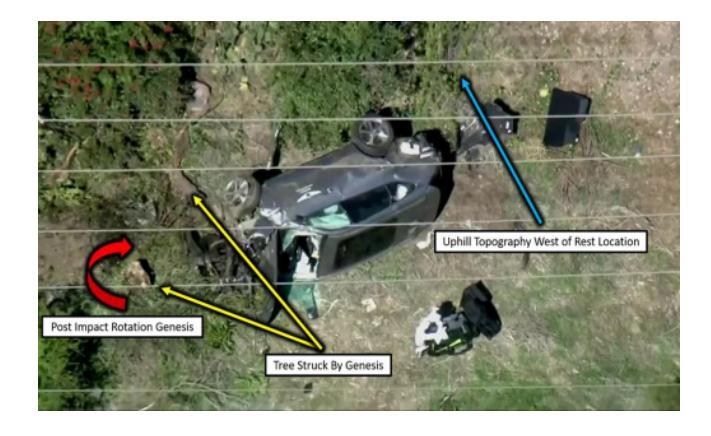
While the Genesis does indeed come to rest on its driver side, this is indicative of the vehicle overturning at the tail end of the collision sequence and not with an extended rollover event, as it is currently being characterized in the news reports. There are no roadway markings consistent with the vehicle overturning prior to departing the west side of the roadway (this departure point being approximately 100 feet from where it ultimately came to rest and approximately 300 feet north of where the vehicle crossed the center median), and the damage pattern to the roof of the vehicle (where there is almost no damage) suggests that the vehicle did not complete a full rotation at any point.

Rather, provided the principal direction of force consistent with the damage to the front of the vehicle (front to rear and centered towards the passenger side) and the damage to the foliage along the west side of the roadway (it appears a large tree/stump has been uprooted as a result of being struck by the Genesis), the data is consistent with the Genesis striking a tree/stump with its front, passenger side and then subsequently rotating in a clockwise direction consistent with the laws of physics. This rotation, coupled with the uphill topography immediately west of where the Genesis came to rest, would introduce a substantive rotational force about the z-axis and promote the overturn onto the driver side.

Here, it is important to point out that most of the damage to the Genesis's front end and the only overturning in the collision sequence both occurred within approximately 20 feet of where the Genesis came to rest. The data is consistent with the vehicle being upright from the point of the loss of control until it struck the tree – or approximately 95% of the 400+ foot travel path across the median and southbound side of the roadway much discussed in current news articles.
